86 yo male s/p EVAR (Talent R main 36x16x175, L 14x16x105, proximal aortic cuff 36x36, R distal extension 18x16x55) of a 8.4 cm AAA . Had a type I endoleak with increasing AAA size to 9.5 cm and was treated with a Zenith Renu 36x50 aortic cuff.

Open AAA repair after failed EVAR,
Aortic occlusion balloon

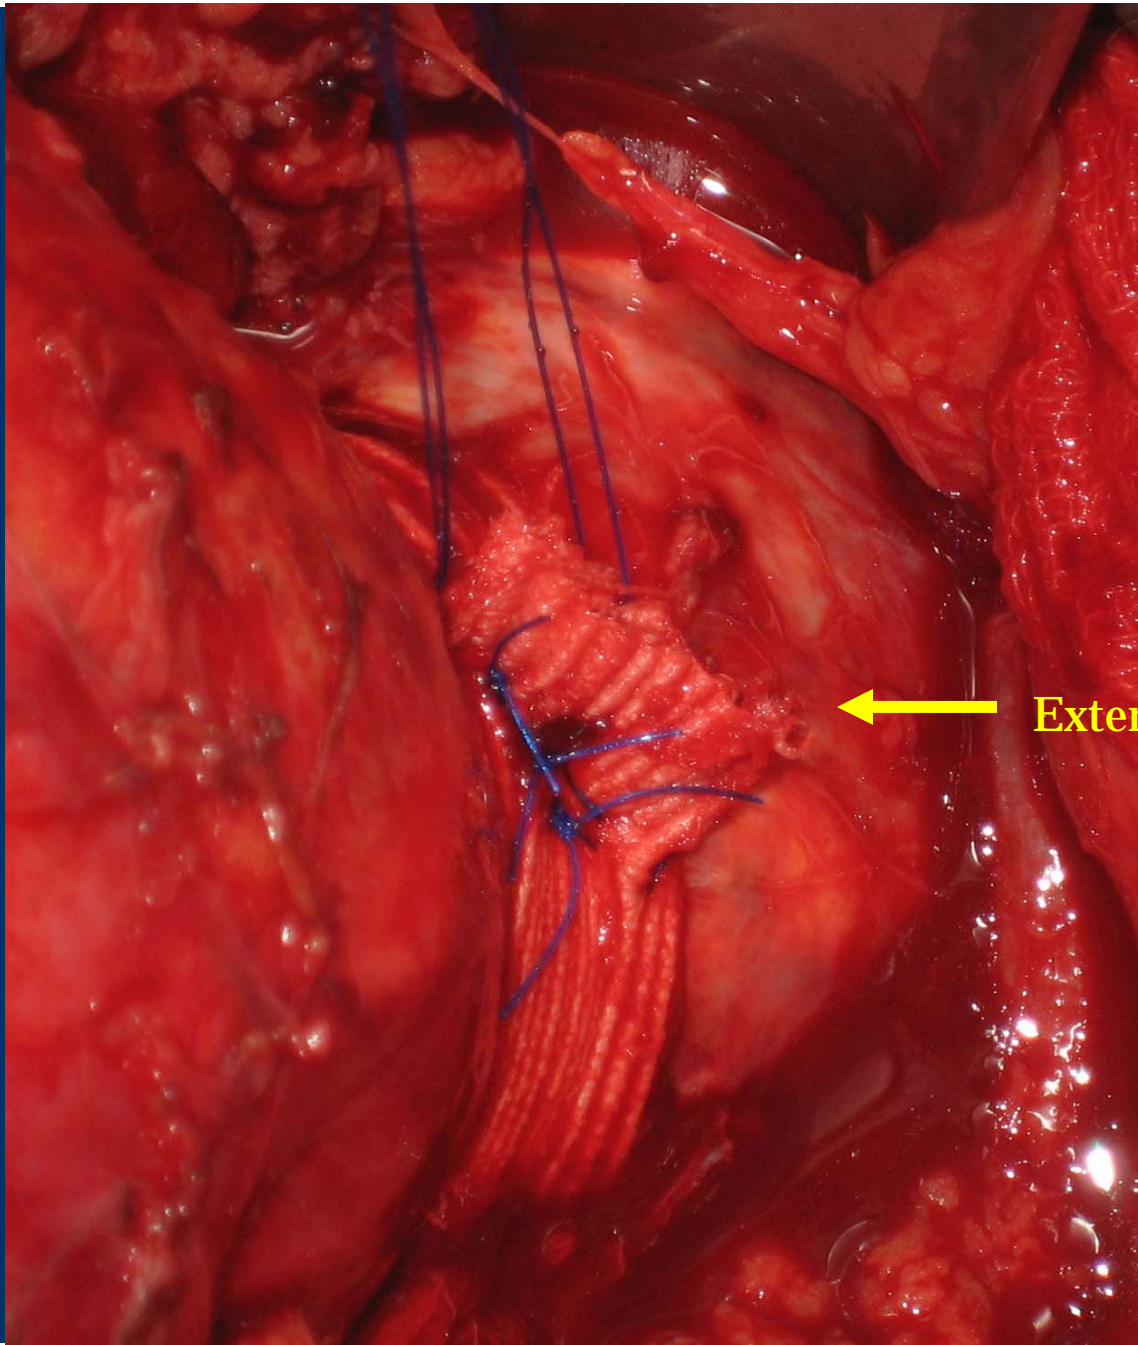
External wrap

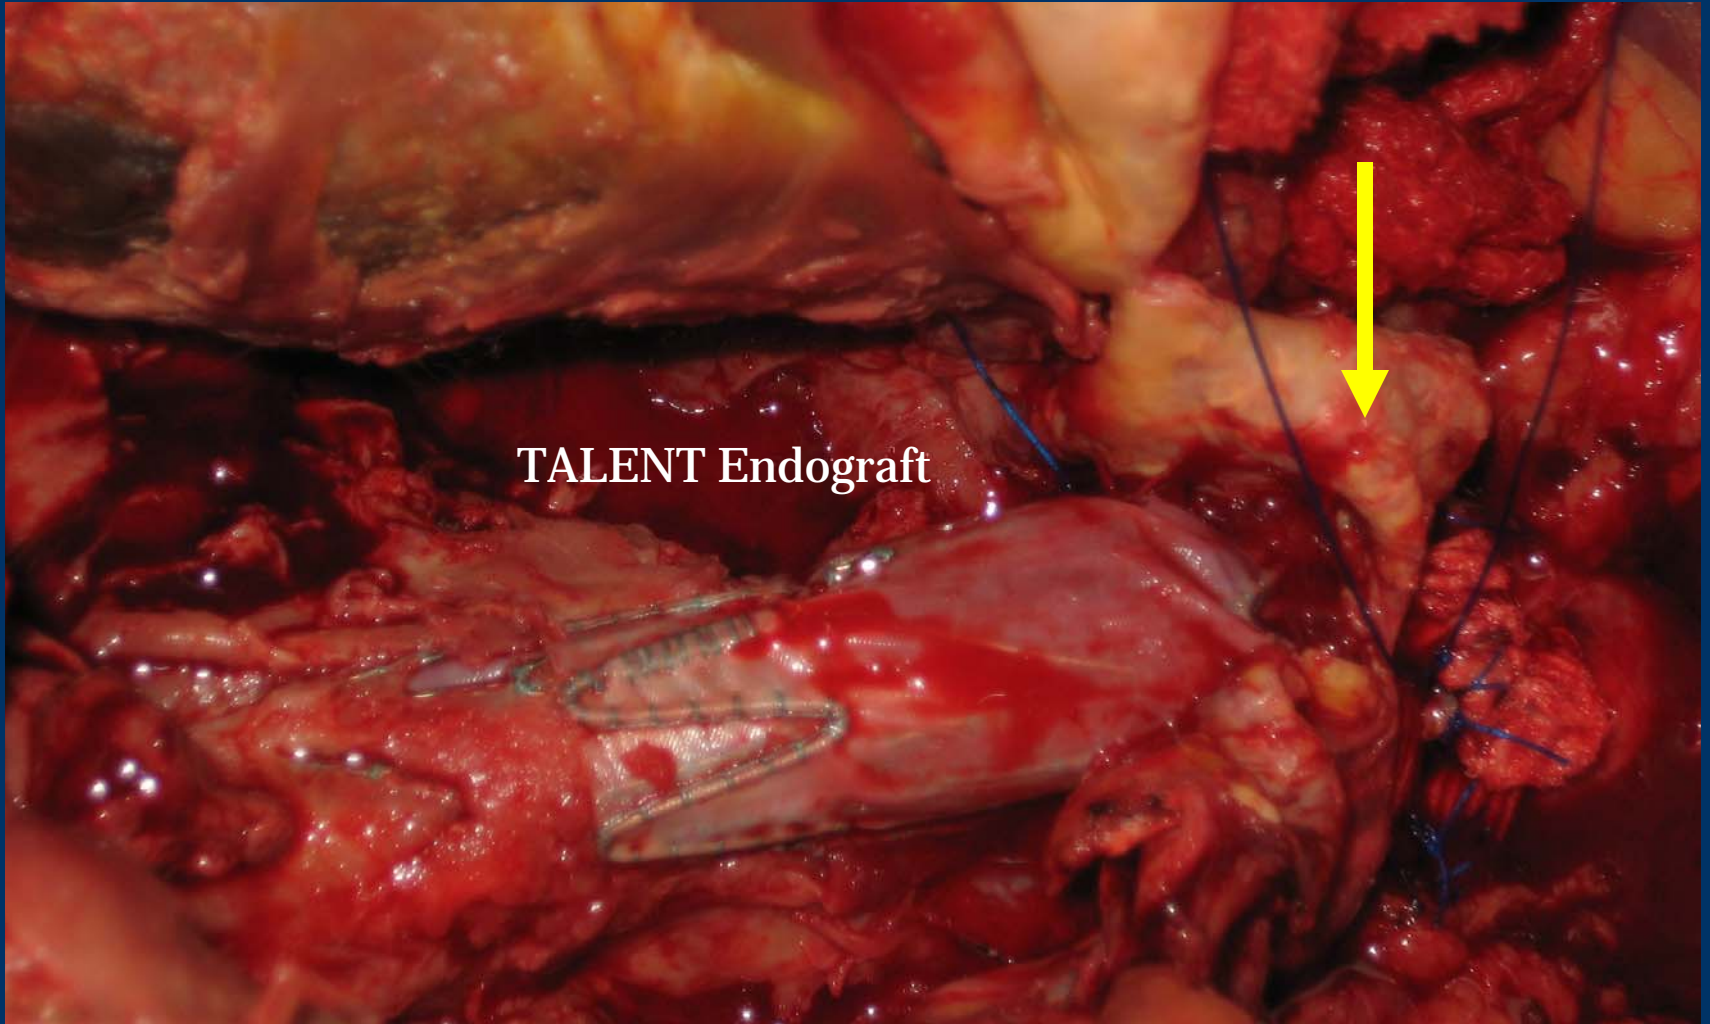
An intraoperative photograph showing a TALENT Endograft in a surgical field. The endograft is a long, cylindrical, reddish-brown mesh-like structure with a central lumen, positioned within a blood-filled cavity. It is held in place by several blue surgical sutures. The surrounding tissue is highly vascularized and appears moist and glistening. The text "TALENT Endograft" is overlaid in white on the left side of the image.

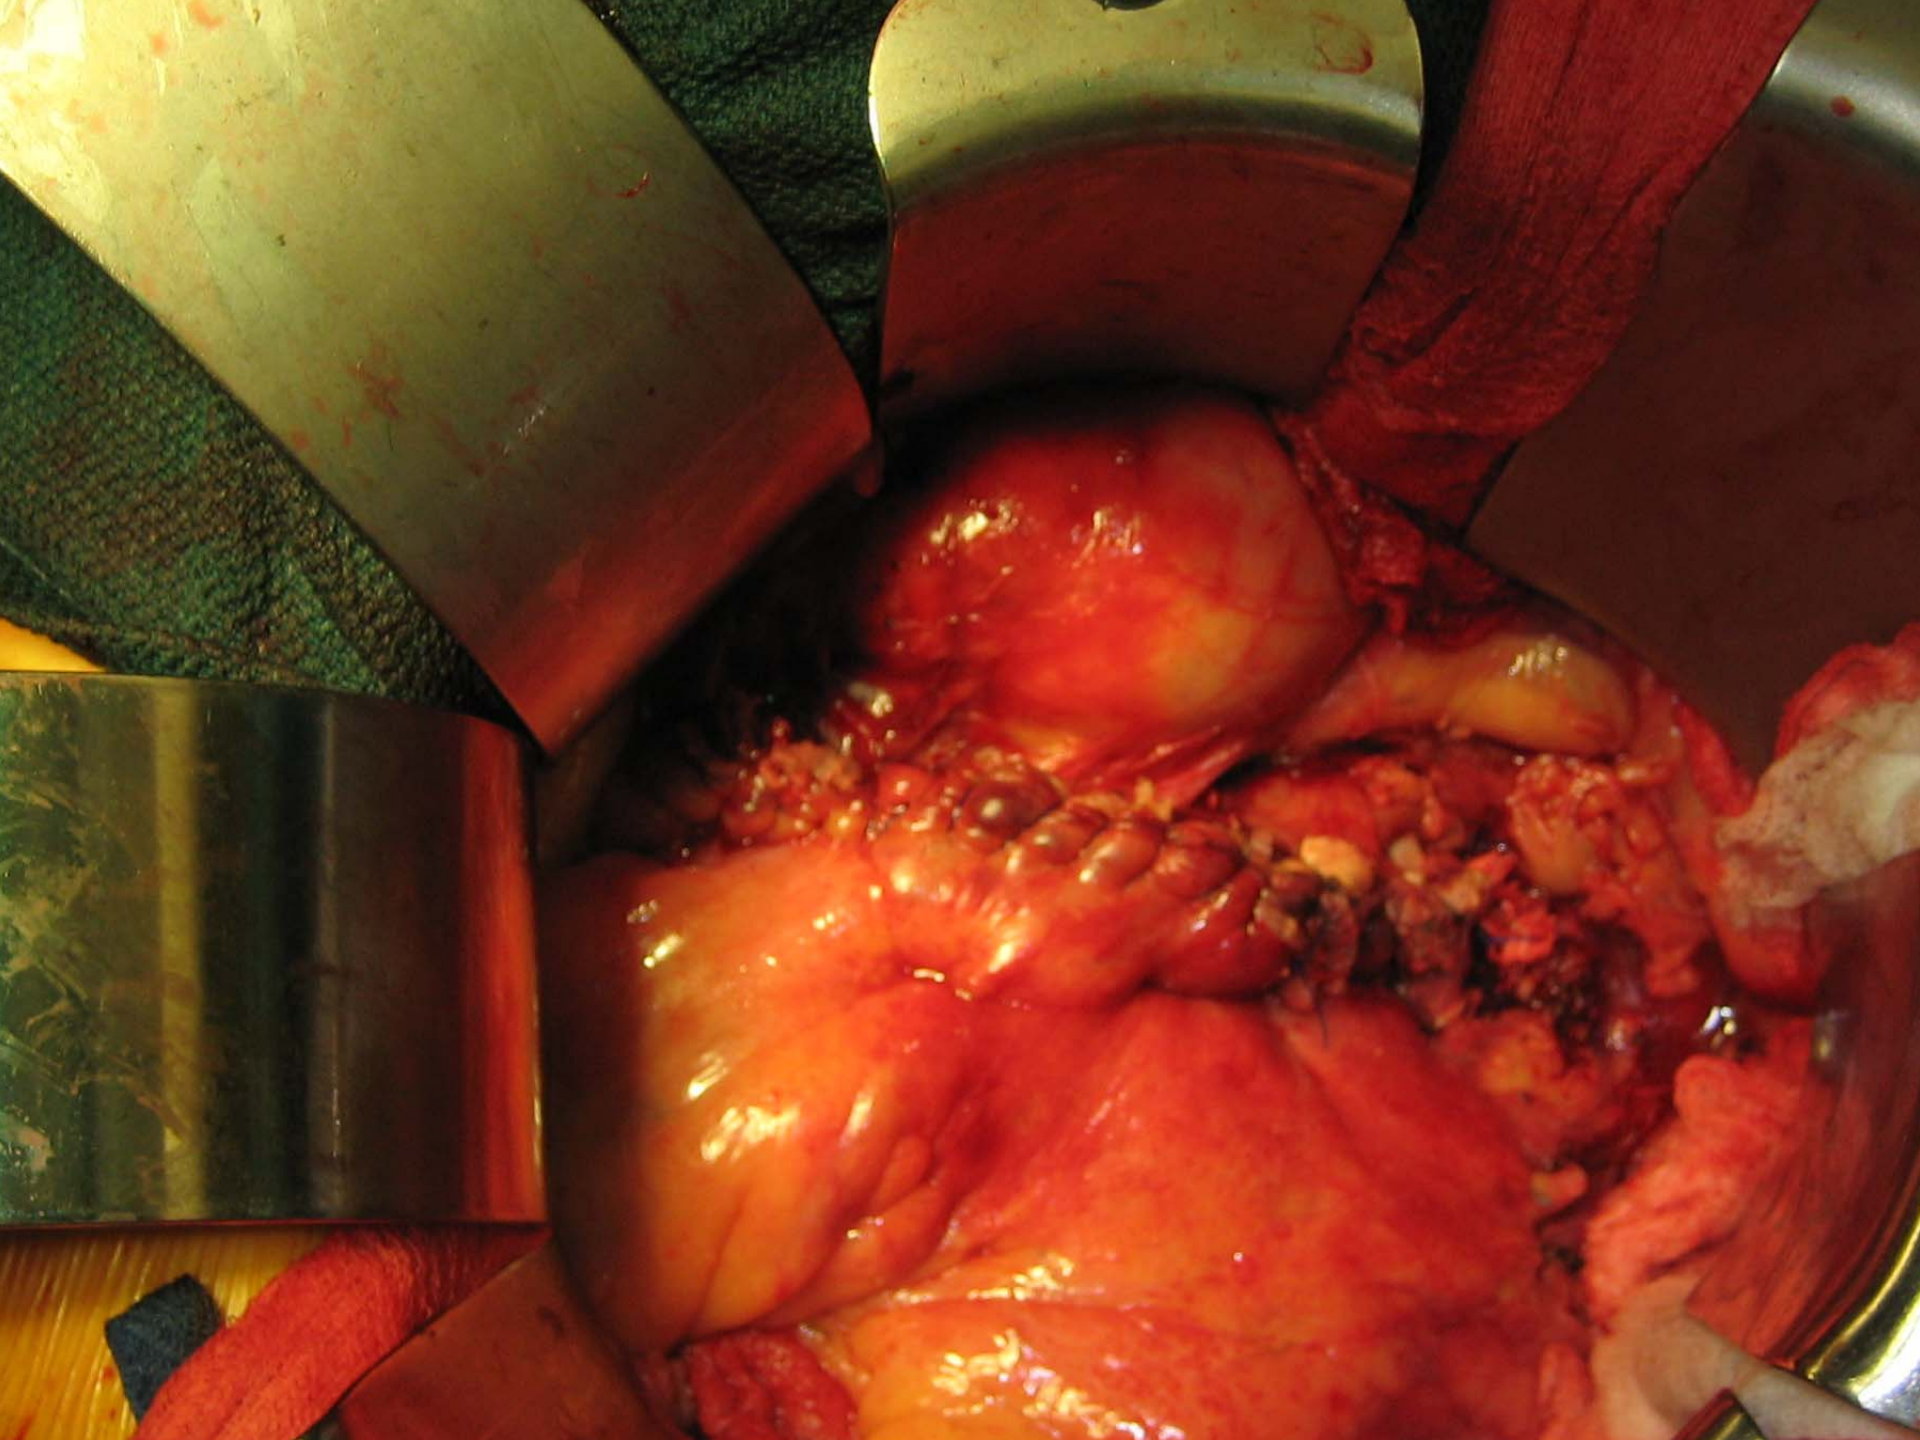
Aneurysmorrhaphy

An intraoperative photograph showing a surgical procedure for aneurysmorrhaphy. The image displays a large, reddish, lobulated aneurysm being repaired. The surgical field is saturated with red, indicating exposed muscle and soft tissue. Several blue sutures are visible, used for securing the repair. The overall scene is brightly lit, highlighting the texture and color of the surgical site.
